Manhole Inspection Summary

Manhole # S33UU_018MH

Insp Date: **4/13/07 10:19 AM**

Location Address: **2800 MACE ST**

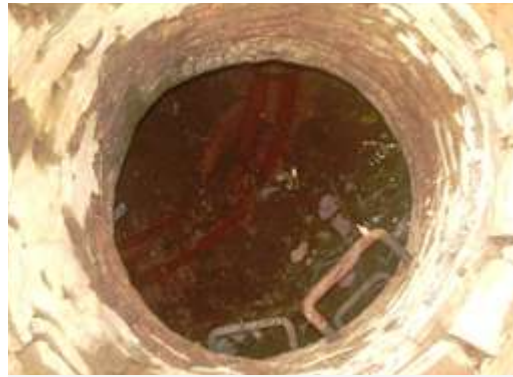
Top View

Corroded steps. Evidence of surcharge - Bench debris. Channel debris.

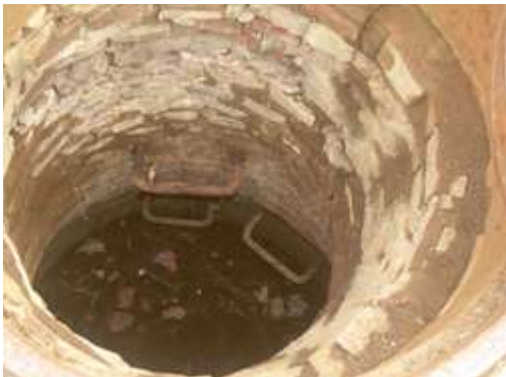
Defect

Frame leaks. Frame offset. Adjustment deterioration and infiltration. Corbel infiltration - other side.

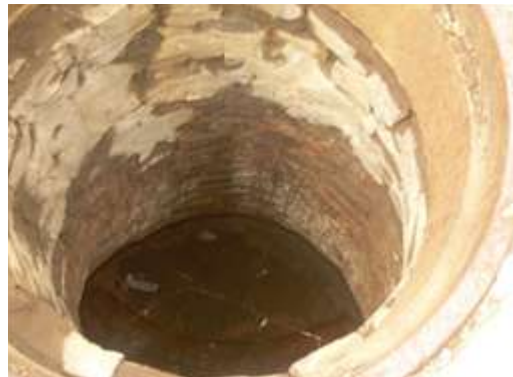
Defect

Frame leaks. Adjustment deterioration and infiltration. Corbel infiltration.

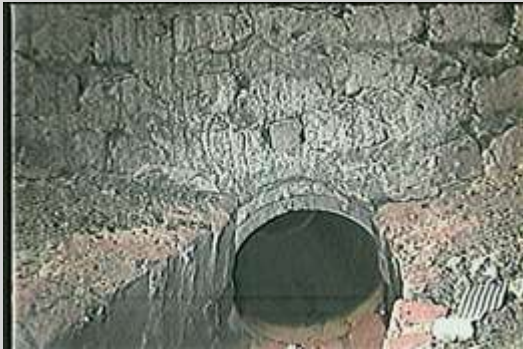
8 in. Circular Gravity Sewer Pipe Out @ 12 O'Clock

Barrel deterioration and infiltration.

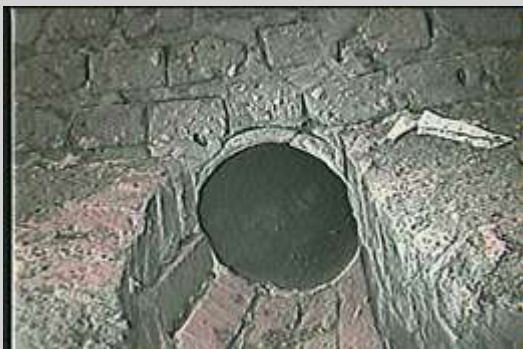
8 in. Circular Gravity Sewer Pipe In @ 9 O'Clock

Channel deterioration.
